ECU list - Motortech

Customer ECU list for MIC, VariStep, Logger, Uninox

SW version 1.8.0

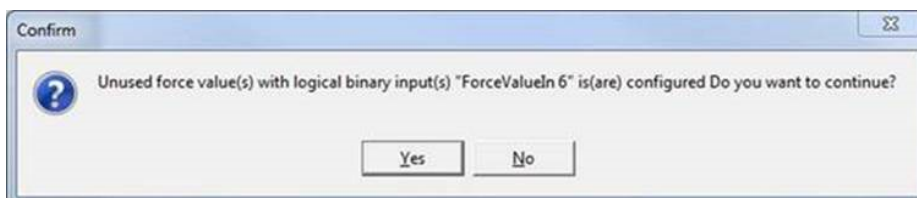
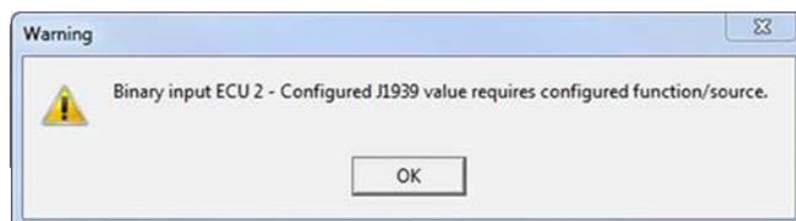
- ▶ SD ECU because of missing frames from ID-Mobile logger
 - Some frames were configured automatically as default and were hidden for user. This caused in some cases wrong evaluation of SD ECU. This feature was removed to allow (un)configure all values.
- ▶ MIC BININ Ready logioindex mapped to Force Value 6
 - When user unconfigures the Force Value, Warning message saying that the input is required appeared. When any ECU with MIC unit was configured, fault causes that binary input Ready in MIC is mapped to Force Value 6. If user wants to use Force Value 6, message saying "Unused Value(s) with logical binary input(s) "Force Value 6" is(are) configured".

This mapping was removed so this happens no more.

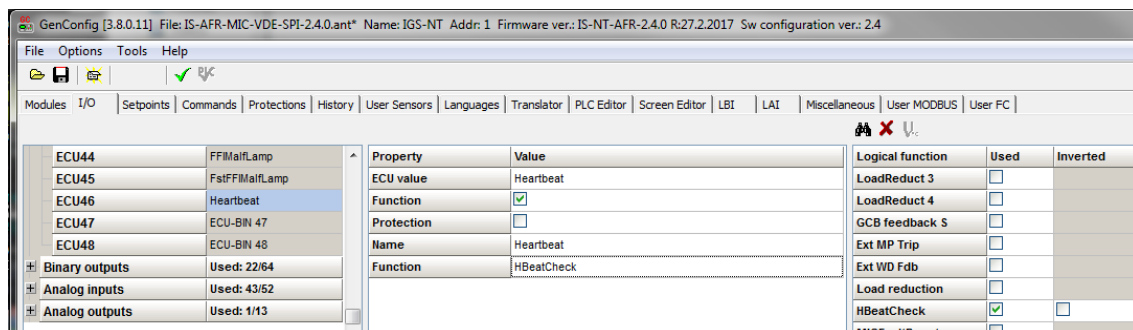
- ▶ MIC address and frame change
 - Conflict frames after merging MIC and Logger support.
 - Change source address of frames read from MIC to 0x34 (52).
- ▶ Heartbeat
 - In order to enable heartbeat control of communication between ID-mobile Logger and IS-NT, there are two new binaries.
 - "Heartbeat" Binary output in Logger eng
 - "Heartbeat" Binary input in MIC+2Varistep+Logger
 - Dataloger heartbeat check – There is BIN from Dataloger in ECU values called Heartbeat. This BIN is automatically configured as input to new HBeatChek function. Output from this function is new LBO HBeatError, this LBO is activated when Heartbeat signal from dataloger is not cycling or cycling slowly. If needed Shutdown can be activated based on this signal. Warning is issued automatically when Heartbeat signal from dataloger is not cycling or cycling slowly.
